Technical Report

2009:4

Establishing Salt Marshes in the Narragansett Bay Research Reserve as Reference Marshes for Long-Term Ecological Monitoring

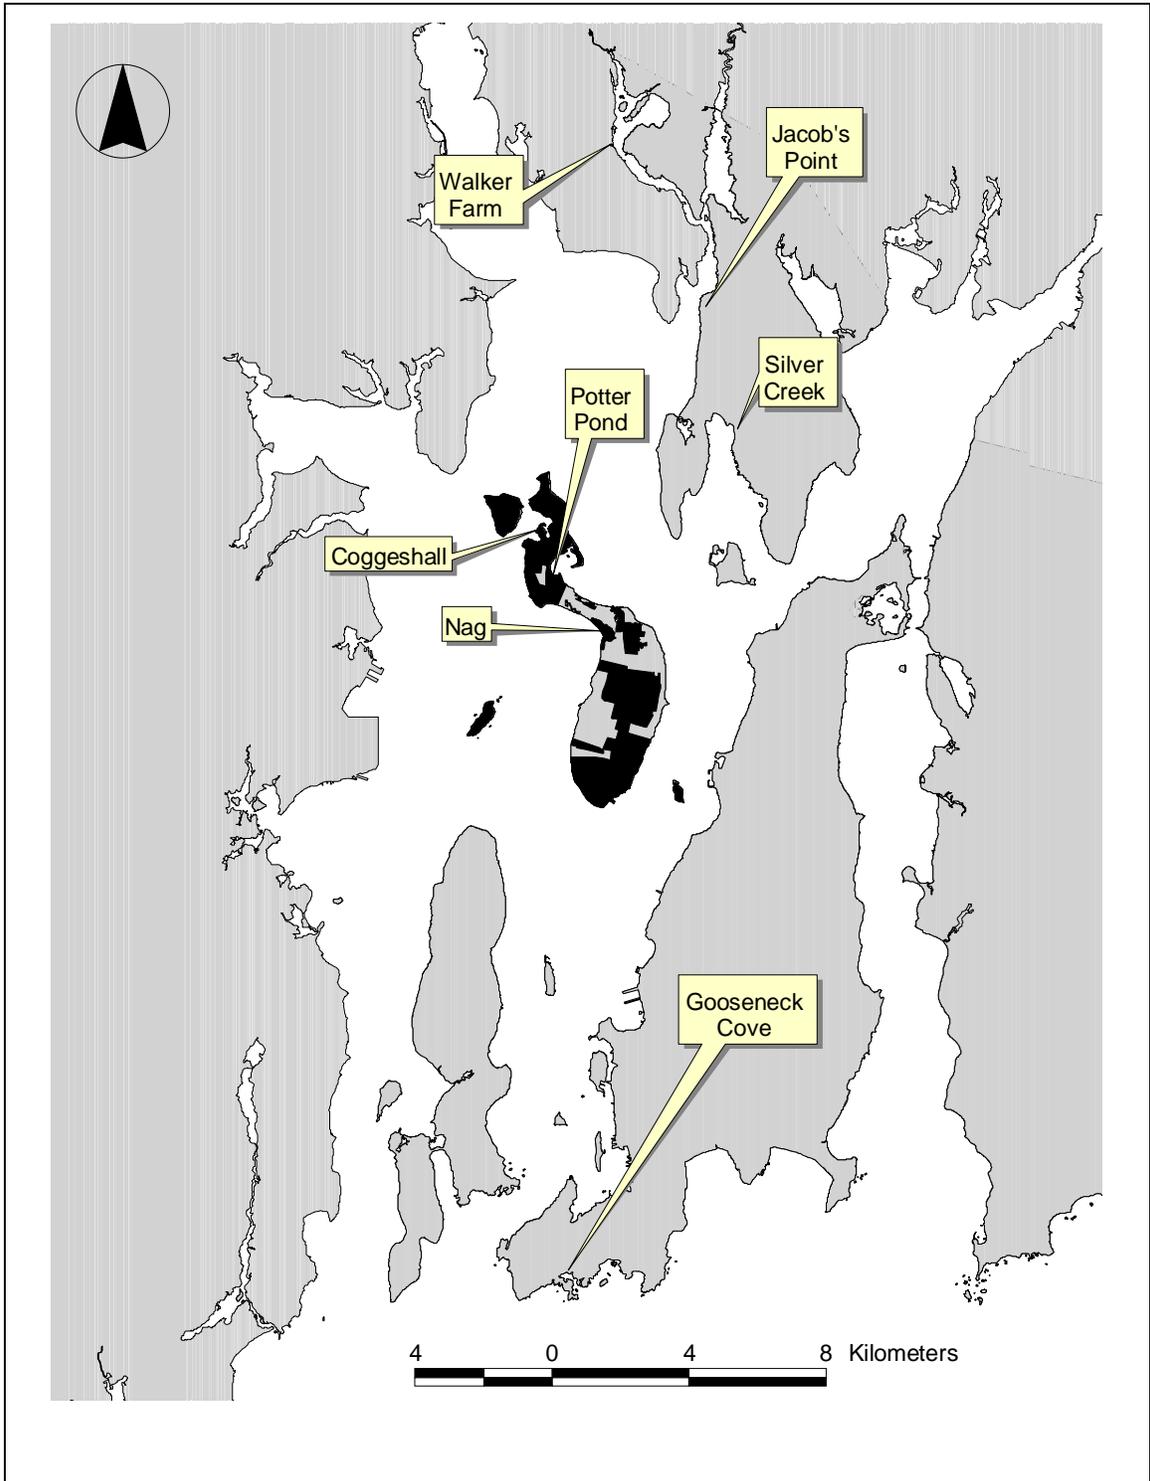
Figure 1. Map of Narragansett Bay showing the locations of Coggeshall and Nag reference salt marshes and the five marshes with altered tidal flow. Land within the Narragansett Bay National Estuarine Research Reserve is indicated in black.

Three of the seven study marshes (Coggeshall Marsh, Nag Marsh, and the restoring Potter Pond Marsh) are located in NBNERR on Prudence Island, which lies in the geographic center of Narragansett Bay (Fig. 1). Walker Farm, Jacob's Point, and Silver Creek marshes are all nearby mainland sites that are located in the heavily developed East Bay section of the Bay. Gooseneck Cove lies just outside the mouth of Narragansett Bay along the southern shore of Newport. All seven marshes lie within 25 km of one another and range from approximately 2-25 ha in size (Table 1).

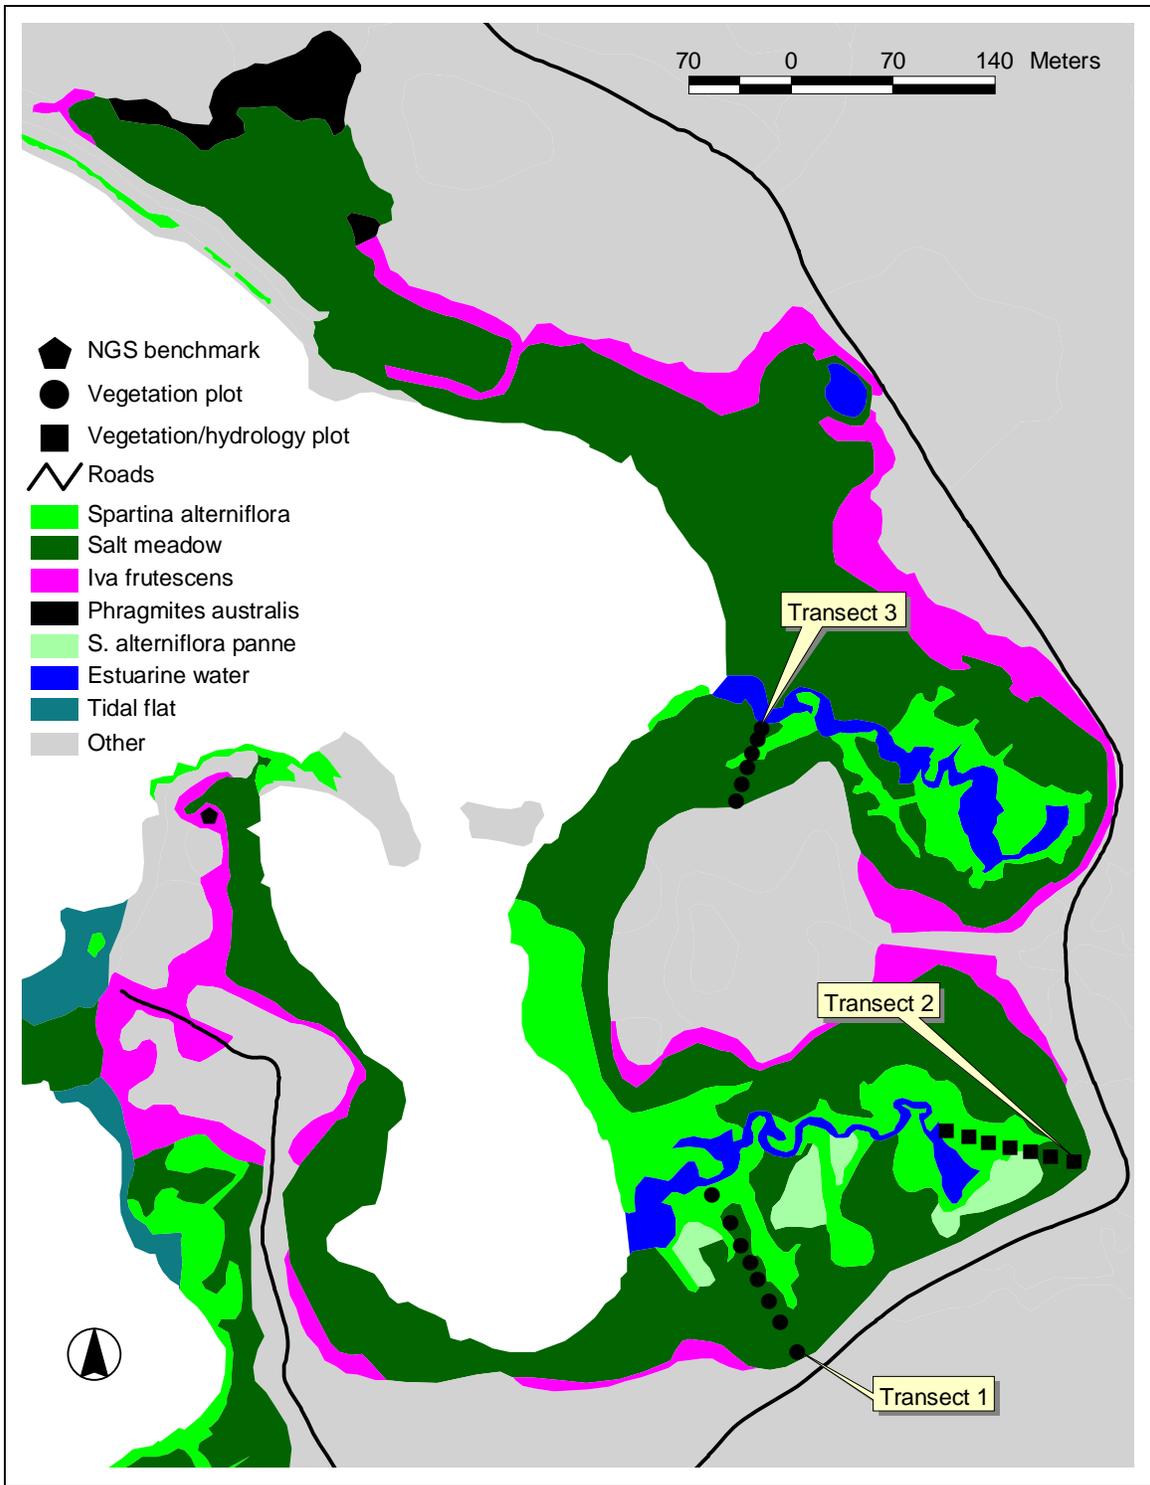
Figure 3. Map of Coggeshall Marsh showing the locations of vegetation and hydrology monitoring plots and an NGS bench mark overlaid on a habitat map of the marsh. The study marsh is bounded to the southwest by a road that passes along the marsh. Habitats were mapped and classified according to Kutcher et al. 2004.

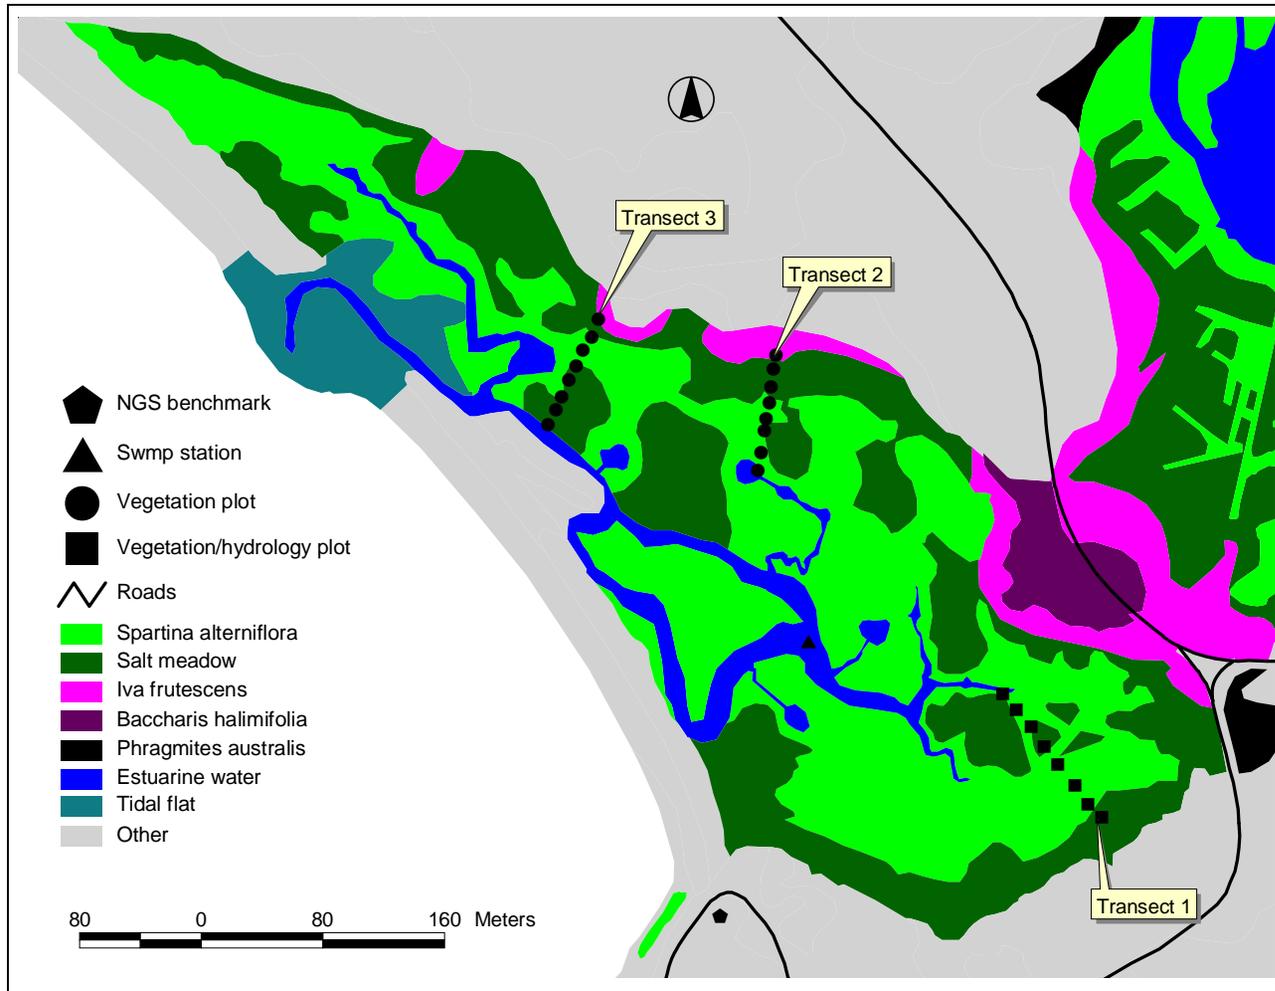
Figure 4. Map of Nag Marsh showing the locations of vegetation and groundwater monitoring plots, a SWMP station, and an NGS bench mark overlaid on a habitat map of the marsh. The study marsh is bounded to the northeast by a road that passes through an *Iva frutescens/Baccharis halimifolia* shrubland. Habitats were mapped and classified according to Kutcher et al. 2004.

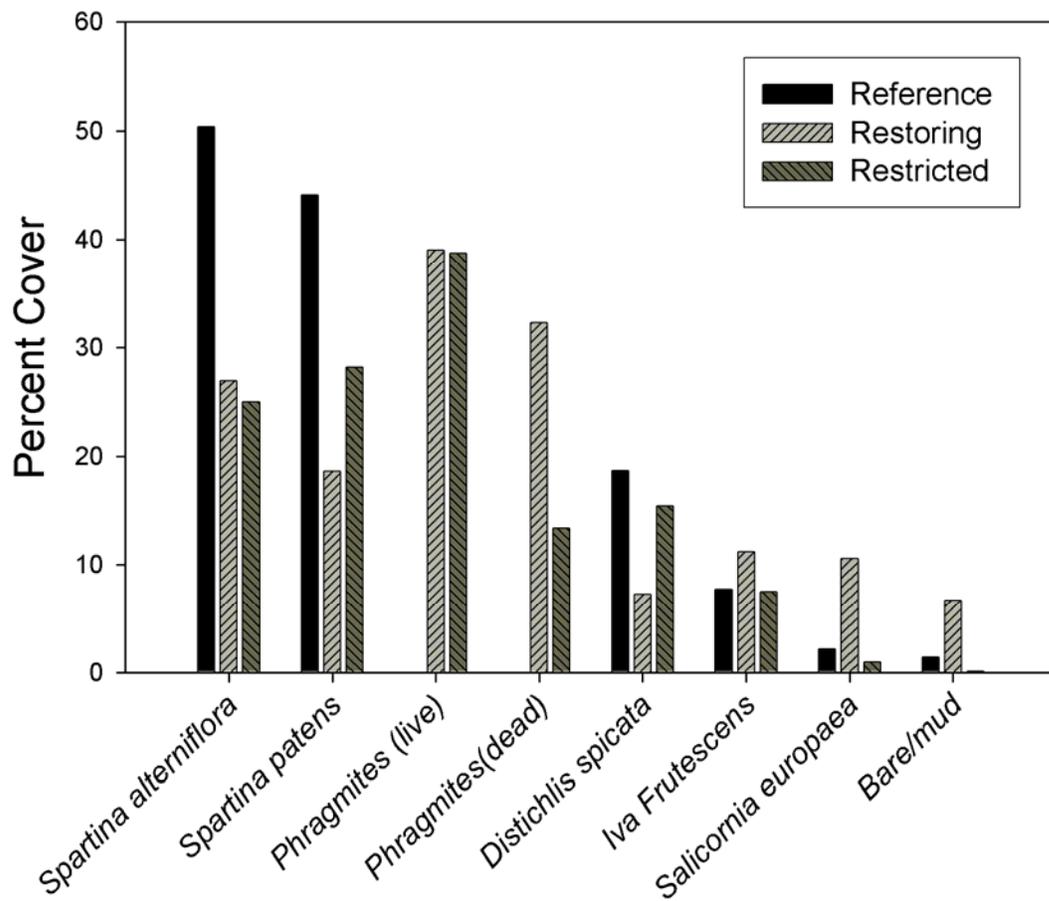
Figure 5. Mean percent cover of dominant vegetation and other cover classes in reference (Coggeshall and Nag), tide-restricted (Gooseneck Cove, Jacob's Point, and Silver Creek), and restoring marshes (Potter Pond and Walker Farm).

typical New England salt marsh vegetation species such as *S. alterniflora*, *S. patens*, and to a lesser extent *D. spicata*, and *Iva frutescens* (Fig. 5). In contrast, the dominant vegetation species in tide-restricted marshes was live *Phragmites*, followed by the two *Spartina* species, dead *Phragmites*, and *D. spicata*. Live *Phragmites* was also the dominant species at restoring marshes, but these marshes also supported more dead *Phragmites*, *Salicornia europaea*, and bare/mud areas than the other marsh types; the latter three components often increase concurrently with restoration-induced increased tidal flows.

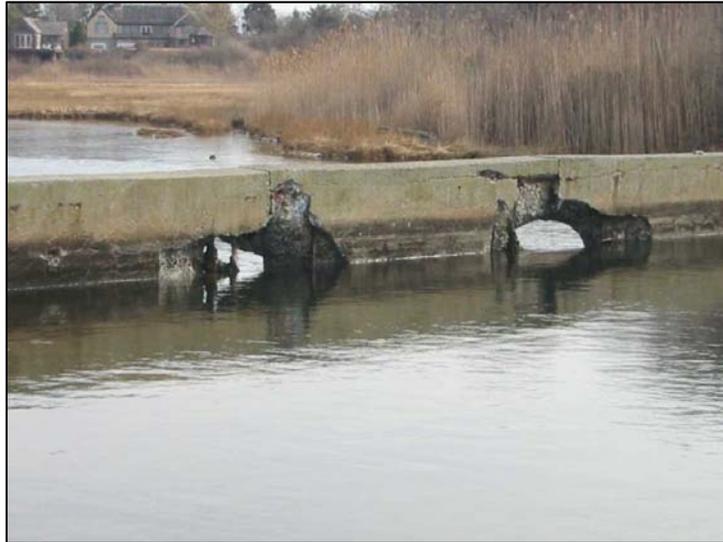
The existing dam is in poor condition (See photo). The culvert in the dam is widening, and other openings have formed. The largest hole has notably increased in size over the last several years, and new fractures have developed more recently. Recent winter storms have threatened the integrity of the dam, creating a potential safety hazard.

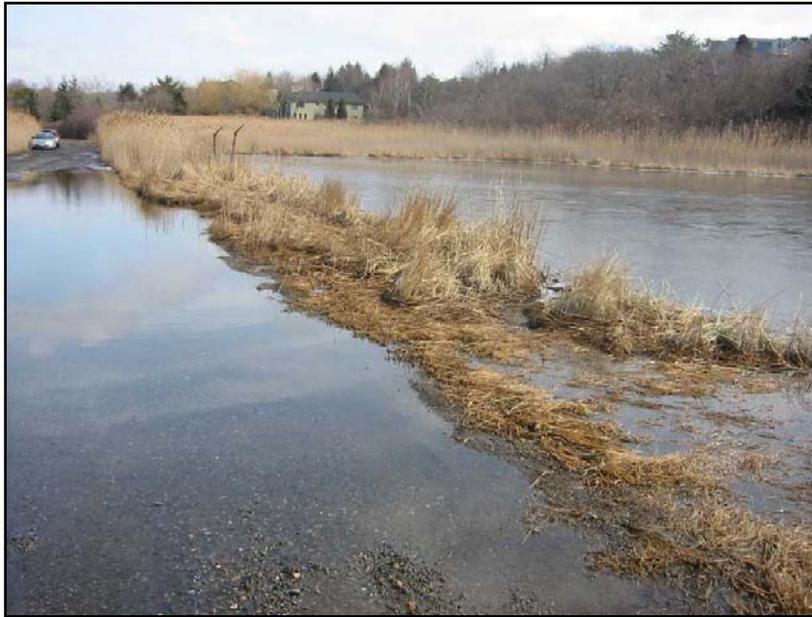
Hazard Road (see photo) is practically impassable at its southern end due to a persistent, deep pool of water. The road was once marsh, and the marsh peat underlying it is subsiding due to the weight of the road. The culvert under the road (about 1.5 foot in diameter) is partially collapsed and does not provide adequate tidal flow.

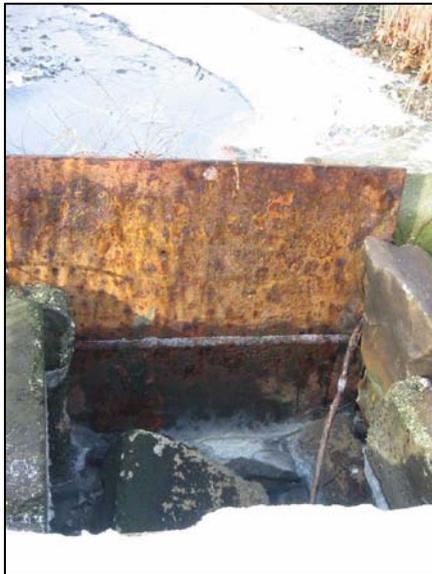
Impacts to the Salt Marsh: Salt water flow into the marsh is inhibited by five tidal restrictions (identified by arrows in the aerial photo). The **southern inlet restriction** is a permanent culverted dam structure that restricts tidal flow. This culvert allows tidal flow into a small portion of the marsh between the dam and the Walker Farm entrance road off Route 114. Saltwater cord grass, *Spartina alterniflora*, is the dominant plant in this section of the marsh. The next tidal restriction to the north is the entrance road off of Route 114 to the community gardens, boat ramp, and composting facility. The small culvert under the road allows minimum tidal flow into the interior marsh. Two overgrown farm roads, located north of the Walker Farm access road, cut across the marsh and prevent further tidal inundation into the interior marsh. At the northern end of the marsh, a flap-gated historic **earthen dam** was built approximately 60 years ago to allow agricultural use of the marsh. Sometime between 1965 and 1970, the Town of Barrington, made this original dam permanent to establish waterfowl habitat.

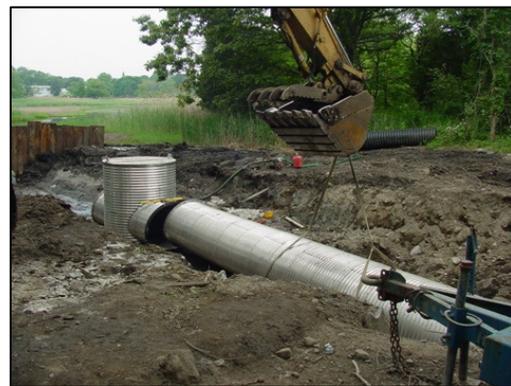
Construction occurred in the summer of 2005. The restoration project included modifying three existing tidal restrictions to improve flushing of the salt marsh. The southern structure includes water control structures to increase tidal flow. The structure under the access road was increased in size to allow for more tidal flow into the marsh

interior. The former farm roads were removed from the marsh surface to improve tidal circulation within the salt marsh. The northern restriction also includes a water control structure. Analysis by URI of the marsh sediment determined that a large amount of sediment would be lost from the marsh if the tidal restoration was removed completely. To address the potential loss of marsh substrate, the northern restriction was designed with a water control structure to limit the initial tidal flow into the marsh. As the marsh revegetates, the water control structure can be modified to allow for greater tidal flow. The marsh spoils were placed in the upland adjacent to the marsh and planted with a conservation mix. A water control structure management plan will be developed based on monitoring trials during spring low and high tides. The water control structures will be maintained by the Town of Barrington in consultation with NOAA, NRCS, Ducks Unlimited, and Save The Bay.
