# Marsh response to shallow runnels

**NERRS & NEERS Salt Marsh Workshop**  
April 26, 2018

Wenley Ferguson, Save The Bay

# Adaptation Strategies

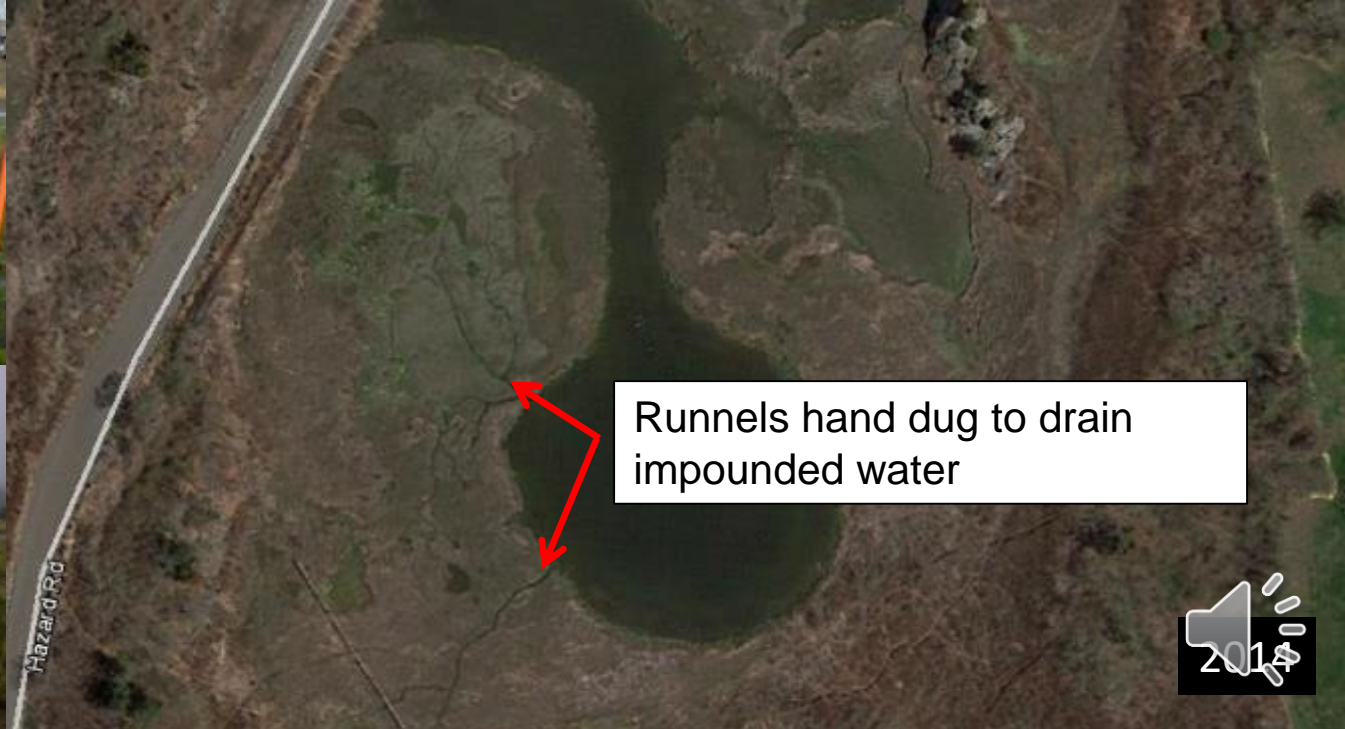
2014

Runnels hand dug to drain impounded water

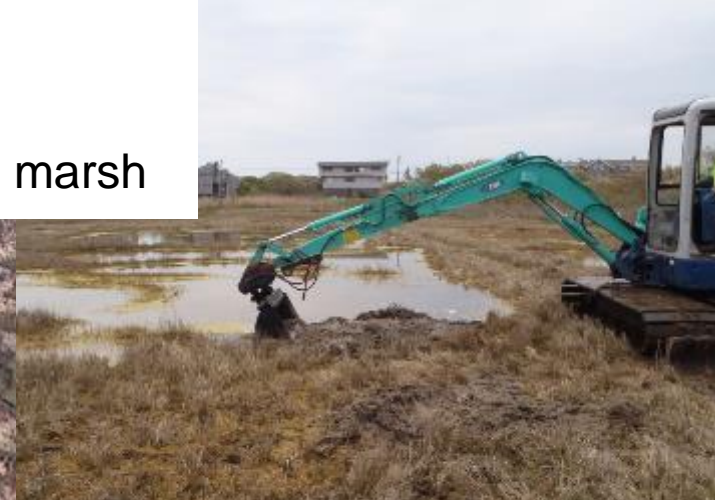
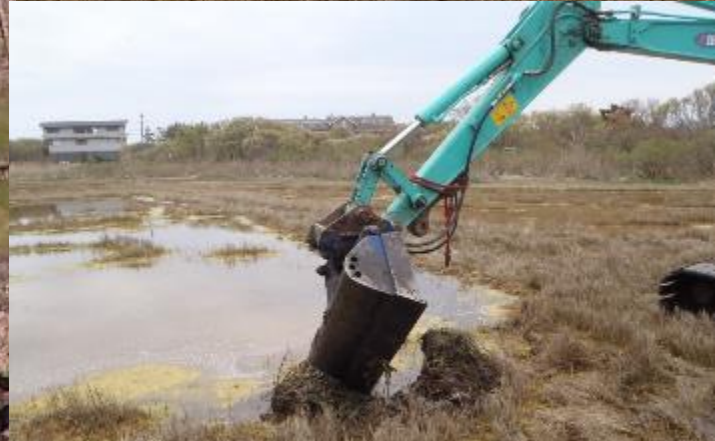
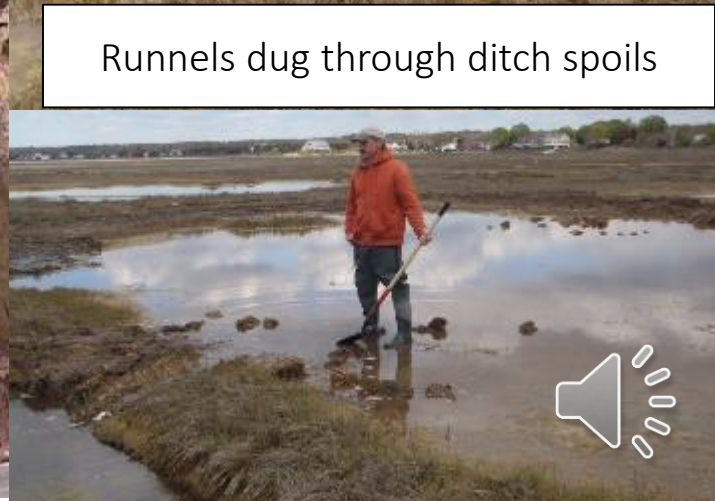
- conducted spring 2013
- runnel excavation through ditch spoils in grid ditched marsh

Runnels dug through ditch spoils

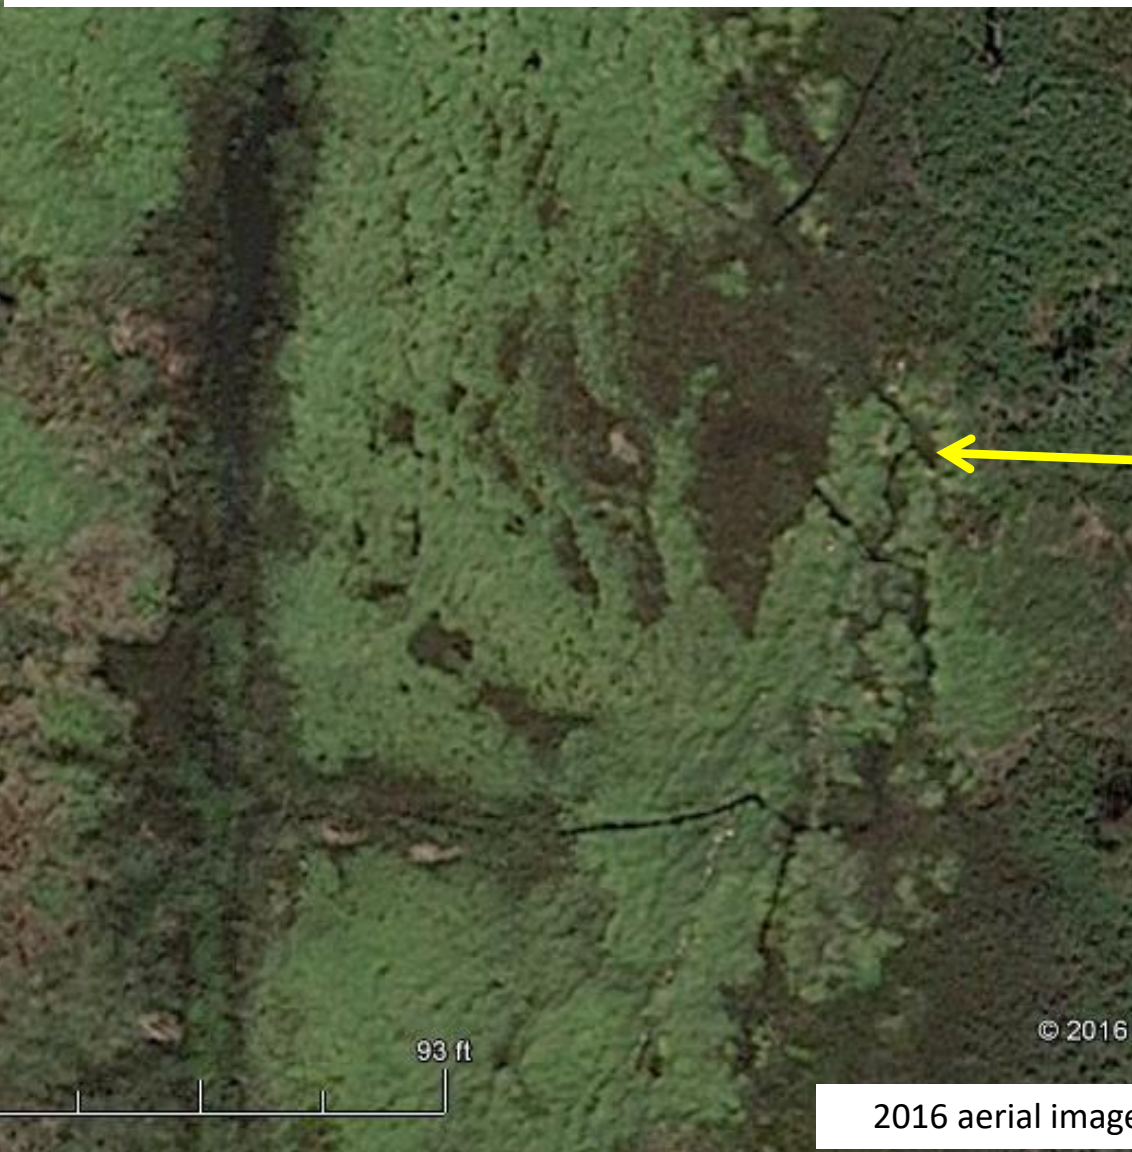
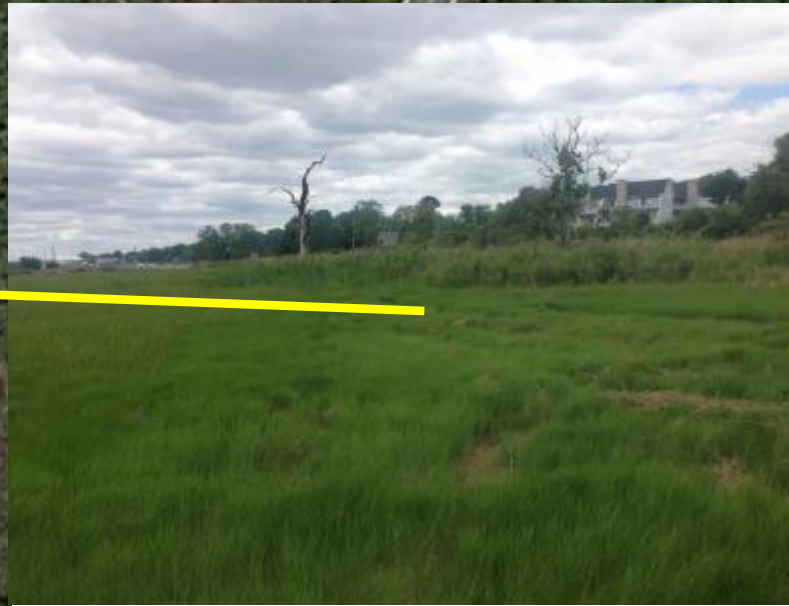
2016 aerial imagery

- Revegetation of bare and impounded water areas
- Degradation not extensive prior to runnel excavation

After 2 growing seasons

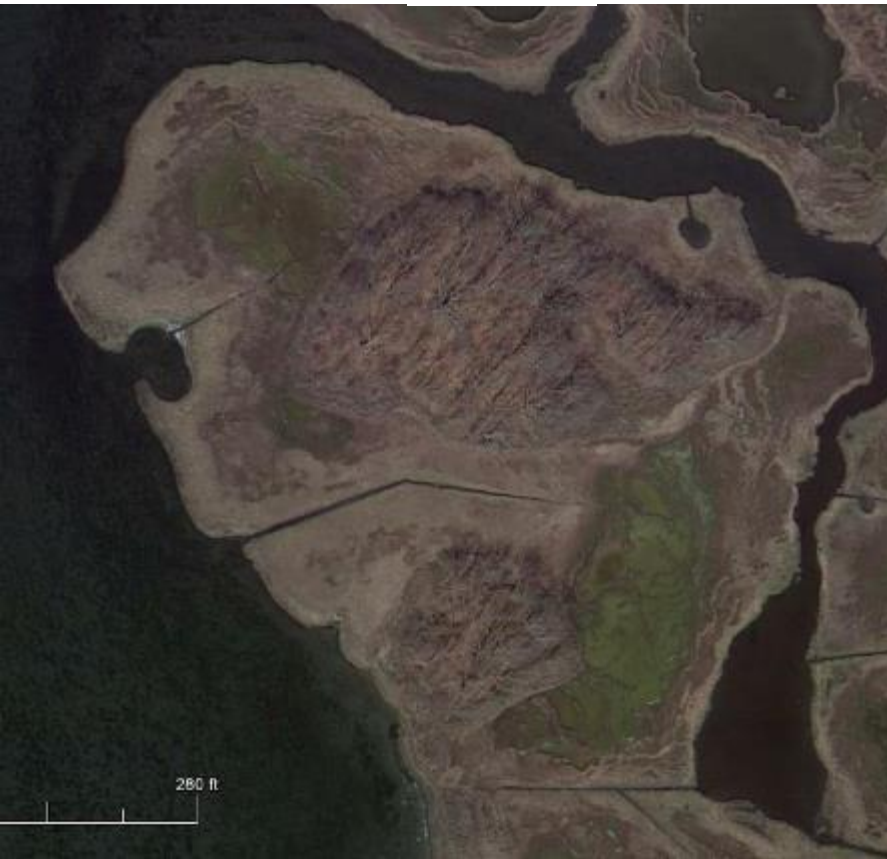
2012

# Middlebridge: marsh elevation 0.2' - 1.4' (Avg: 0.9')

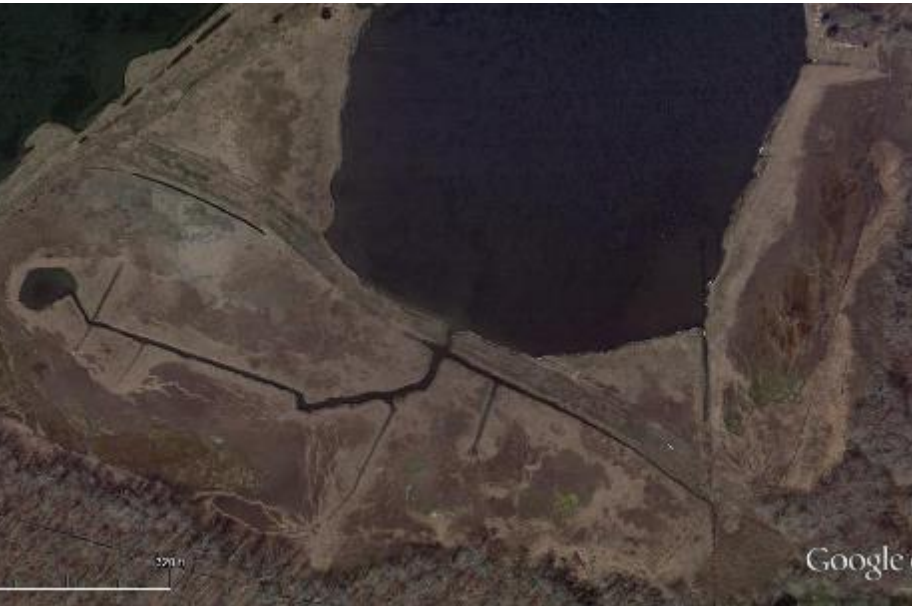
2012

marsh elevation: 0.9 -1.6 (Avg: 1.3')

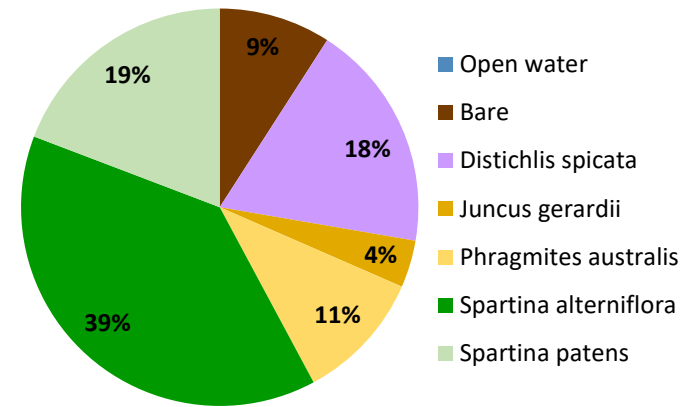
## 2016 post runnel

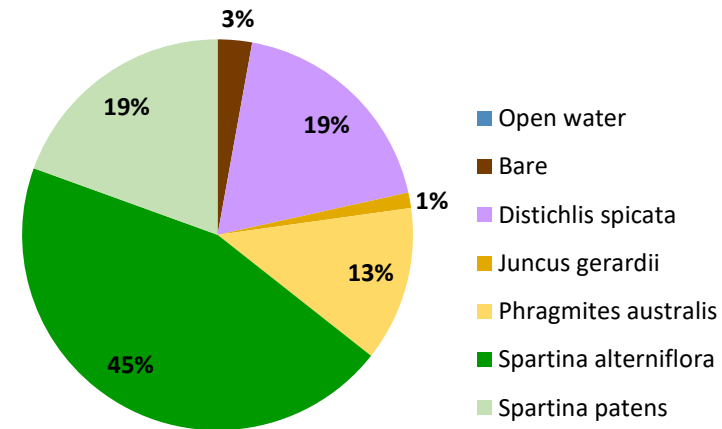
## 2017 post runnel

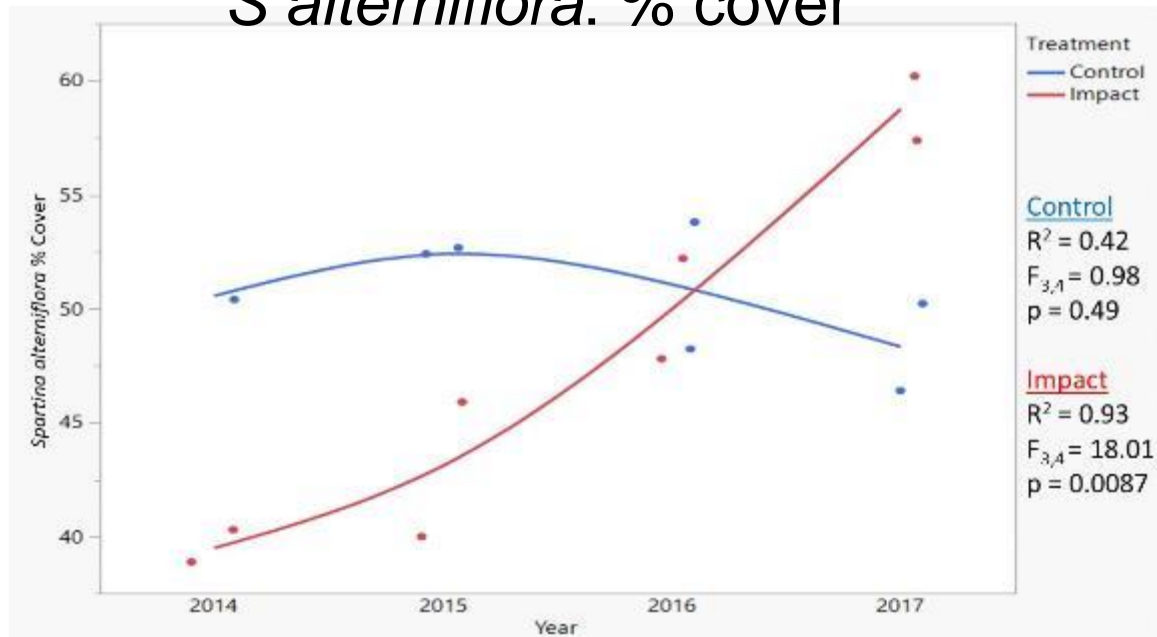
# *S alterniflora*: % cover

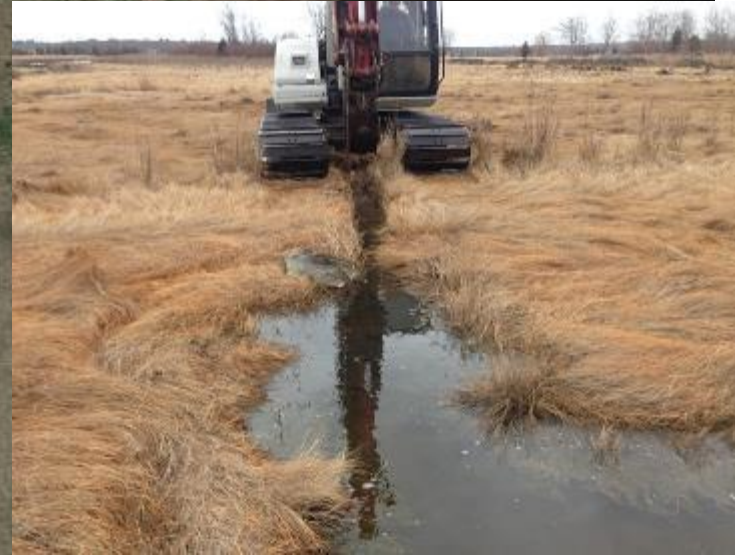
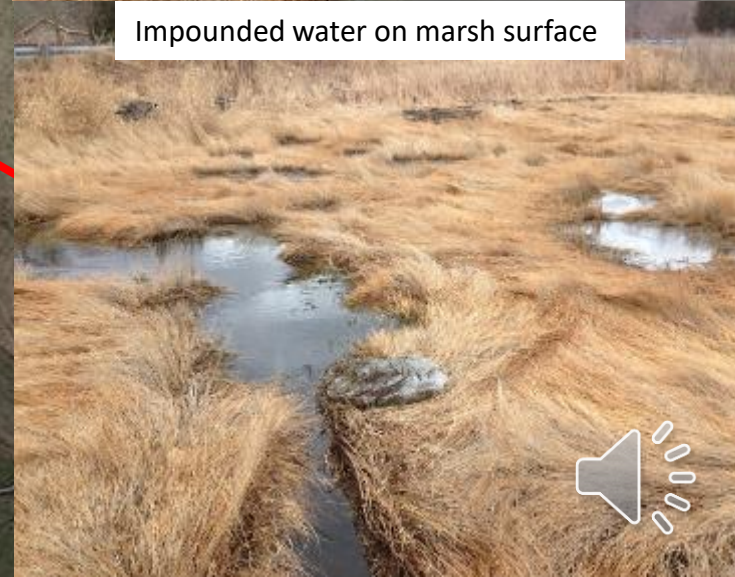
- high marsh still in tact, expanding depressions in upper marsh

Impounded water on marsh surface

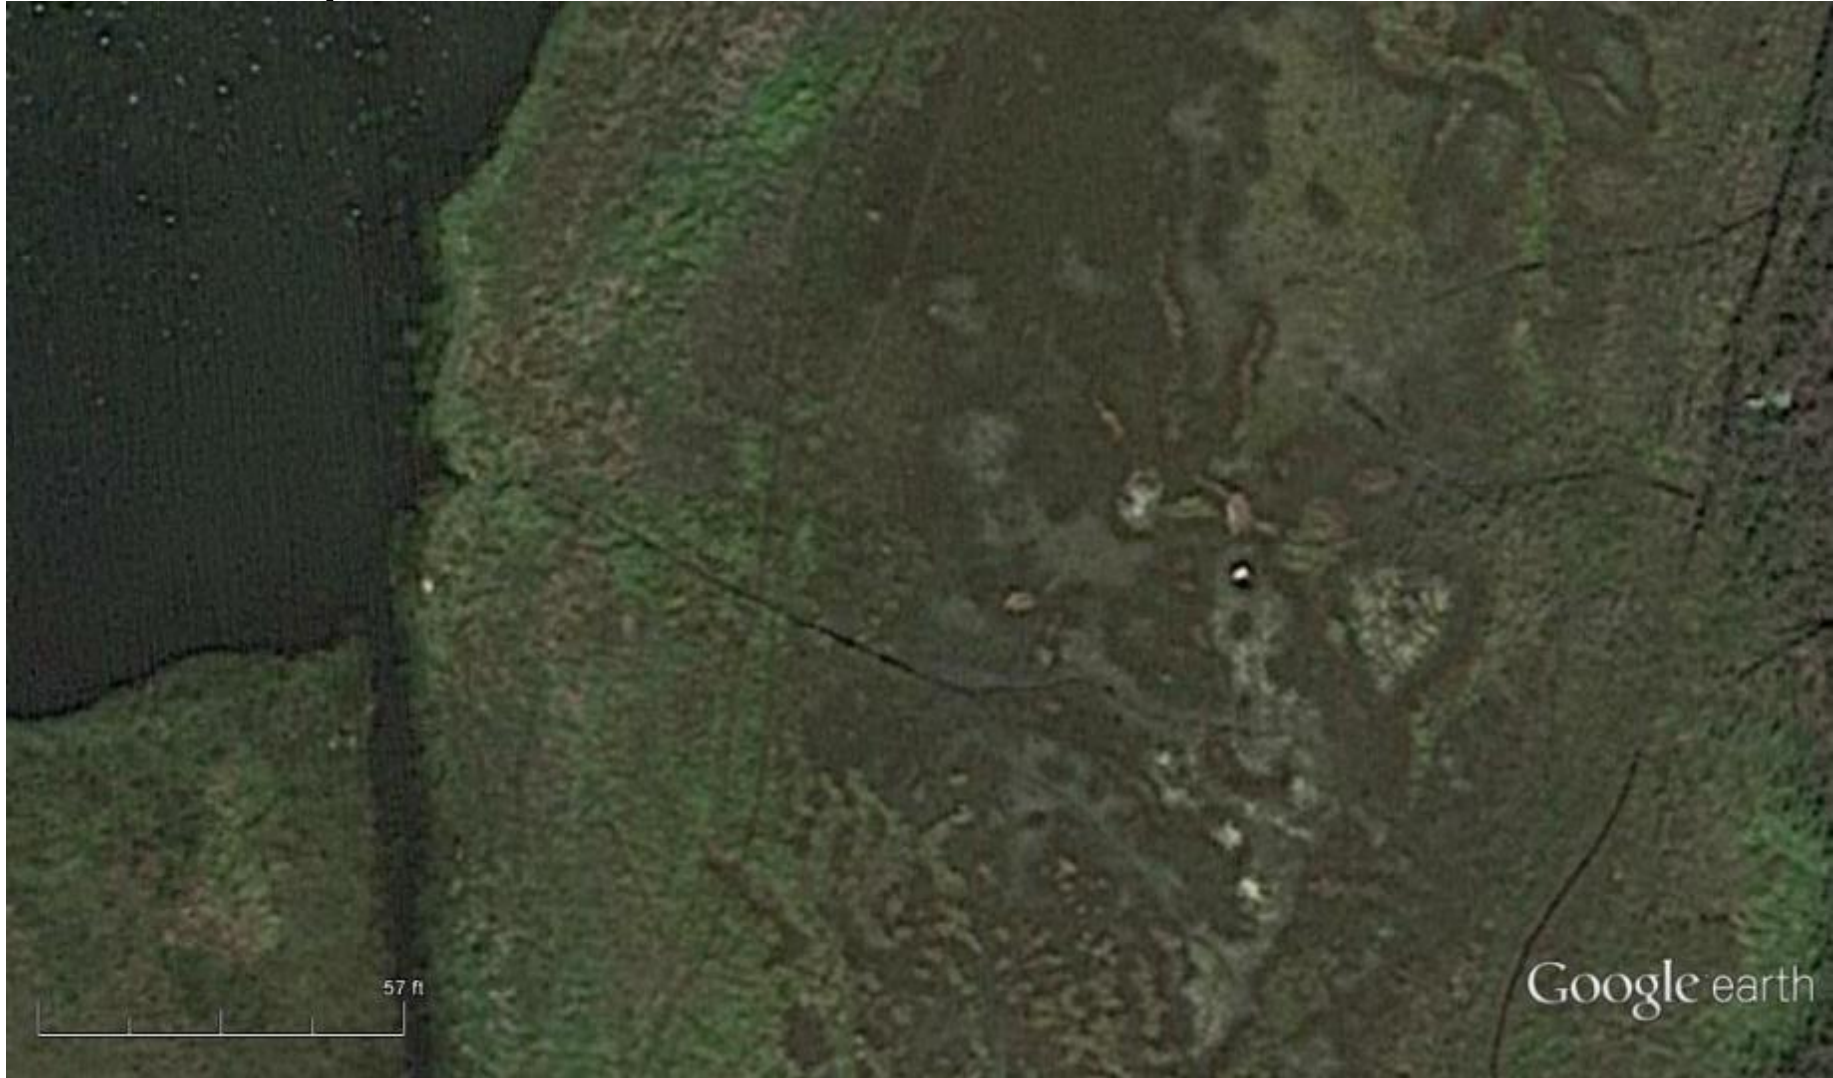
# Example of marsh sill

- If marsh elevation is too low, marsh unlikely to revegetate and scouring could result due to the volume of water flooding and draining during a tidal cycle
- Runnels in upper marsh and in marsh migration corridor greatest recolonization
- Maintain sills at the mouth of runnels to prevent excessive drainage
- Conduct project in phases to allow marsh to revegetate and stabilize unconsolidated sediments
- Peat is gold! Keep it on the marsh surface
