**Report on the Analysis of True Color Aerial Photography to
Map and Inventory *Zostera marina* L. in
Narragansett Bay and Block Island, Rhode Island**

Mike Bradley
Environmental Data Center
University of Rhode Island

Kenneth Raposa
Narragansett Bay National Estuarine Research Reserve

Sue Tuxbury
Save the Bay

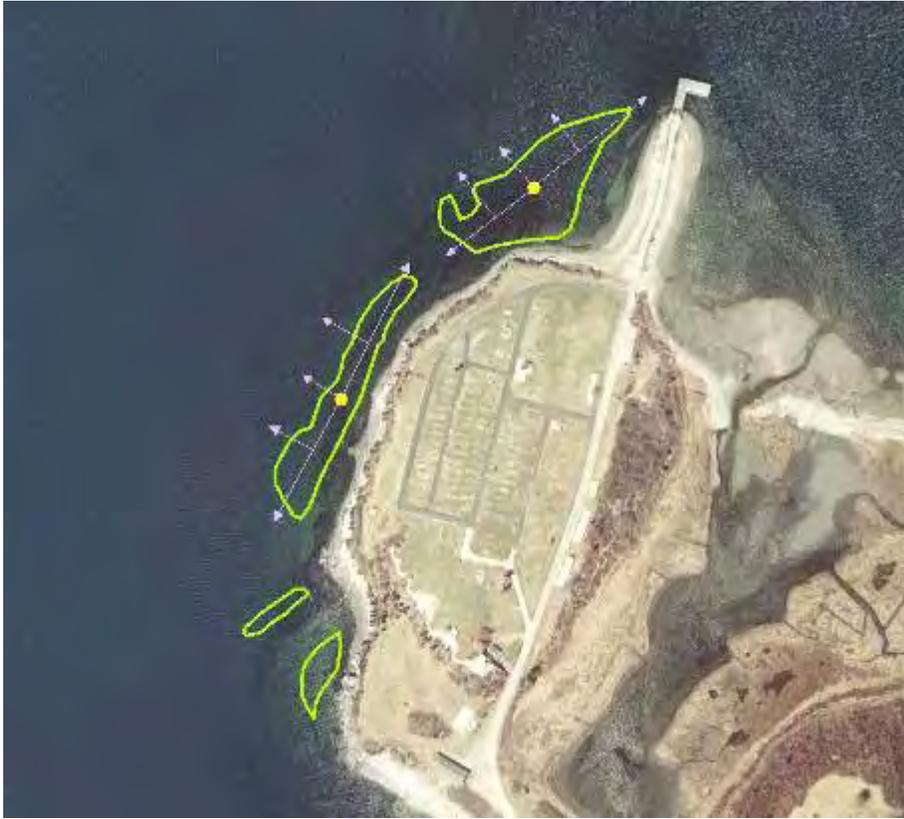
Figure 2. A strategy for field-mapping eelgrass beds was developed whereby GPS and video data were collected at the intersection of the arrows and polygons to determine the deepwater edge and extent of each eelgrass bed.

During ground-truthing, an effort was made to visit all delineations, locate the center of each delineation and if eelgrass was present, to determine the deepwater edge and the extent of the bed (Fig. 2). GPS data points were collected and coded for presence of eelgrass within and at the edge of eelgrass beds. In order to estimate errors of omission during the photo-interpretation process, additional GPS data points were collected and coded for presence of eelgrass at distance intervals along the shoreline where eelgrass is known to occur (e.g., East Passage Narragansett Bay, Fig. 3). Deepwater edges and the

extent of the beds were determined at low tide using underwater video equipment, fathometer signals, view scope observations, and in limited cases, volunteer divers. The edge of an eelgrass bed was considered to occur when cover dropped to about 5-10%. Delineations were then re-digitized in the field using a GPS enabled tablet pc or in the lab using GPS data and field notes. Field delineations and observations were incorporated into the final GIS database.

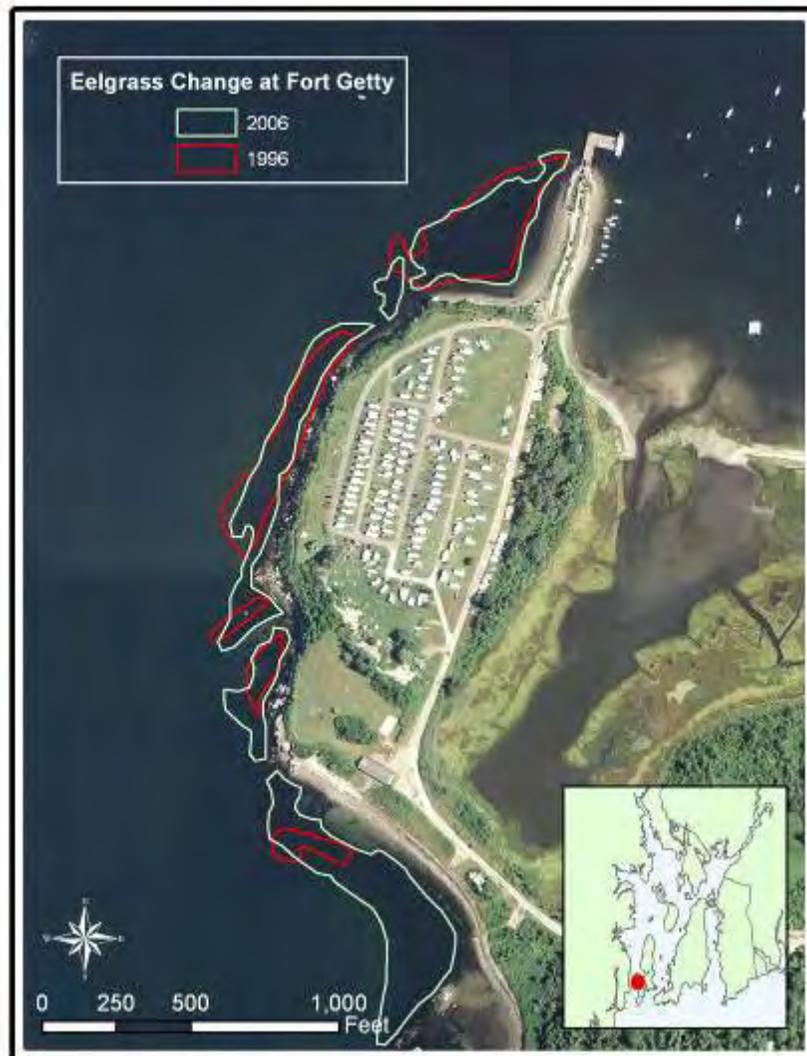
Figure 7. The eelgrass extent at Fort Getty in Jamestown over a 10 year period seems relatively unchanged in some areas and shows large increases in others. The 1996 data were adjusted slightly to account for differences in geo-registration.

At three sites within Narragansett Bay (Potters Cover, T-wharf, and Fort Getty) we were able to analyze and assess changes in areal extent of eelgrass cover over a 9 to 10 year period. At these sites, substantial increases in areal extent of eelgrass were observed from 1996 to 2006. When generally compared to the 99.6 acres mapped in 1996, our efforts (over 400 acres) would seem to show a substantial increase of eelgrass in Narragansett Bay. Tiner et al. (2007) also observed increases in eelgrass areal cover from 2002 – 2006 in Long Island Sound. However, it is worth noting that even if eelgrass cover has increased during the past 10 years in Narragansett Bay, the present acreage is still an order of magnitude less than the 6000 acres of eelgrass that occurs in Buzzards Bay, MA, an estuary of comparable size to Narragansett Bay (Costa, 2001). Also, eelgrass historically covered a much greater range throughout Narragansett Bay, including Greenwich Bay and the Providence River (Rhode Island Habitat Restoration Team, 2001)
